NATIONAL DAM INSPECTION PROGRAM HARTFORD RESERVOIR
NUMBER 6 EAST DAM (CT..(U) CORPS OF ENGINEERS WALTHAM
MA NEW ENGLAND DIV JUN 79

DEPARTMENT OF THE ARMY
NEW ENGLAND DIVISION, CORPS OF ENGINEERS
424 TRAPELO ROAD
WALTHAM, MASSACHUSETTS 02154

PHASE I INSPECTION REPORT
HARTFORD RESERVOIR NUMBER SIX DAMS
SECTION I - PROJECT INFORMATION

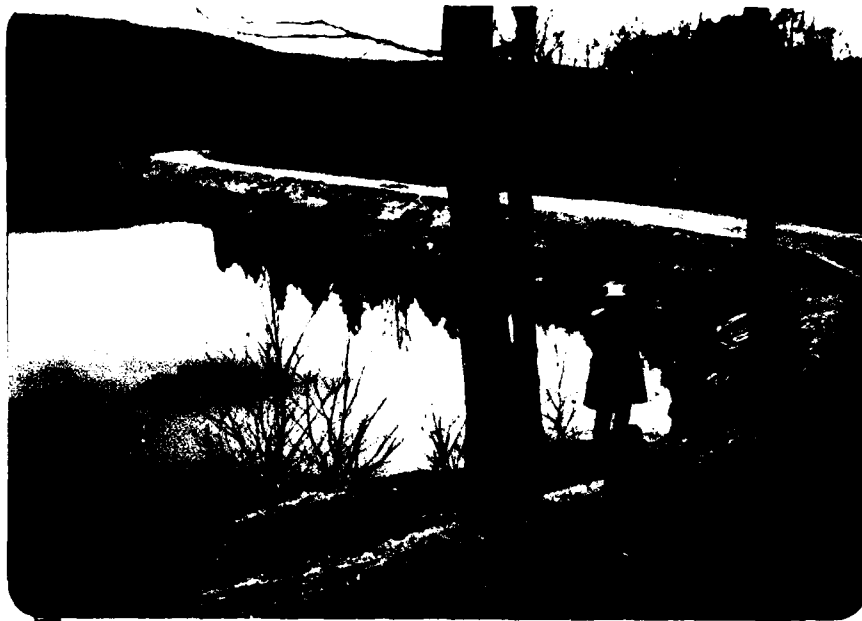
Crest - The crest has a typical width of approximately 16 feet and is used extensively as a walkway and jogging path. As such, it is covered with sand and gravel for nearly its entire length (Photo 3). The crest is paved at the left (north) end of the dam for a distance of 600 feet to provide an access road for the gatehouse (Photo 8). The crest is consistently in good condition along both the sand and gravel, and the paved portions. It appears to be at a uniform elevation with no signs of problem erosion, settlement, movement or cracking.

PHOTO 3 - View of portion of crest and upstream slope of East Dam from right abutment. Riprap and crest typical of all dam.
